Common Hazards to Avoid with Power Cords

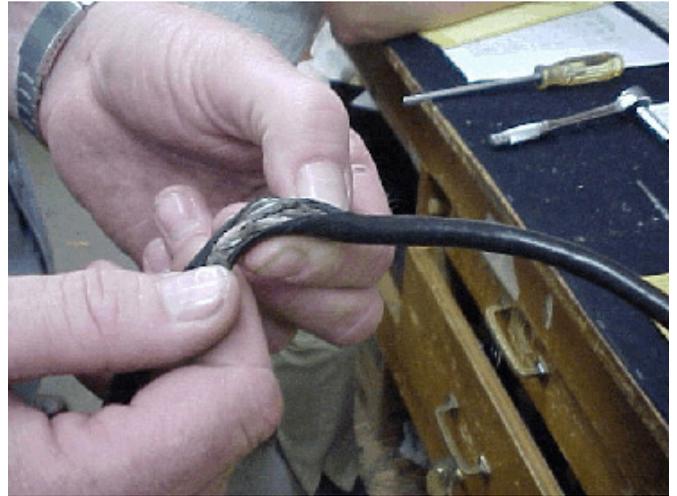
Pictured is a power cord for a shop appliance. The cord has been sliced open, exposing the energized wires. The appliance was still plugged in and still in use.

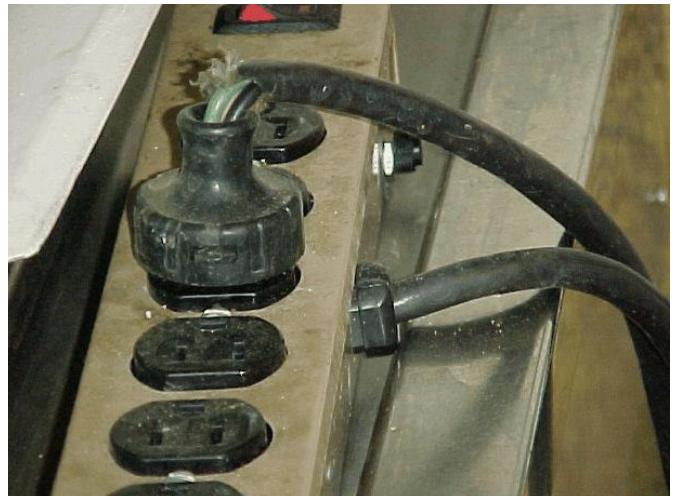
The power cord above has had its protective sheathing torn away from the plug head, exposing energized wires.
